STATE OF VERMONT Division for Historic Preservation  VERMONT ARCHITECTURAL RESOURCE INVENTORY*  Individual Property Survey Form	SURVEY NUMBER: (Assigned by VDHP)
	Listed in State Register <input type="checkbox"/> Date:
	Determined Eligible for State Register <input type="checkbox"/> Date:
	PRESENT FORMAL NAME:
	ORIGINAL FORMAL NAME:
COUNTY: Lamoille	PRESENT USE: Residence
TOWN: Morrisville	ORIGINAL USE: Residence
ADDRESS: 573 Laporte Rd.	ARCHITECT/ENGINEER: N/A
COMMON NAME:	BUILDER/CONTRACTOR: N/A
PROPERTY TYPE: House	DATE BUILT: c. 1882
OWNER: ADDRESS: Jersey Heights Residences LLC 29 Birch St. South Burlington, VT 05403	
ACCESSIBILITY TO PUBLIC: Yes <input type="checkbox"/> No <input checked="" type="checkbox"/> Restricted <input type="checkbox"/>	PHYSICAL CONDITION OF STRUCTURE: Good <input type="checkbox"/> Fair <input type="checkbox"/> Poor <input checked="" type="checkbox"/>
LEVEL OF SIGNIFICANCE: Local <input checked="" type="checkbox"/> State <input type="checkbox"/> National <input type="checkbox"/>	STYLE: Italianate

RECORDED BY: Alex Tolstoi

ORGANIZATION: Vermont Property Preservation Consultants

DATE RECORDED: 5/6/2022

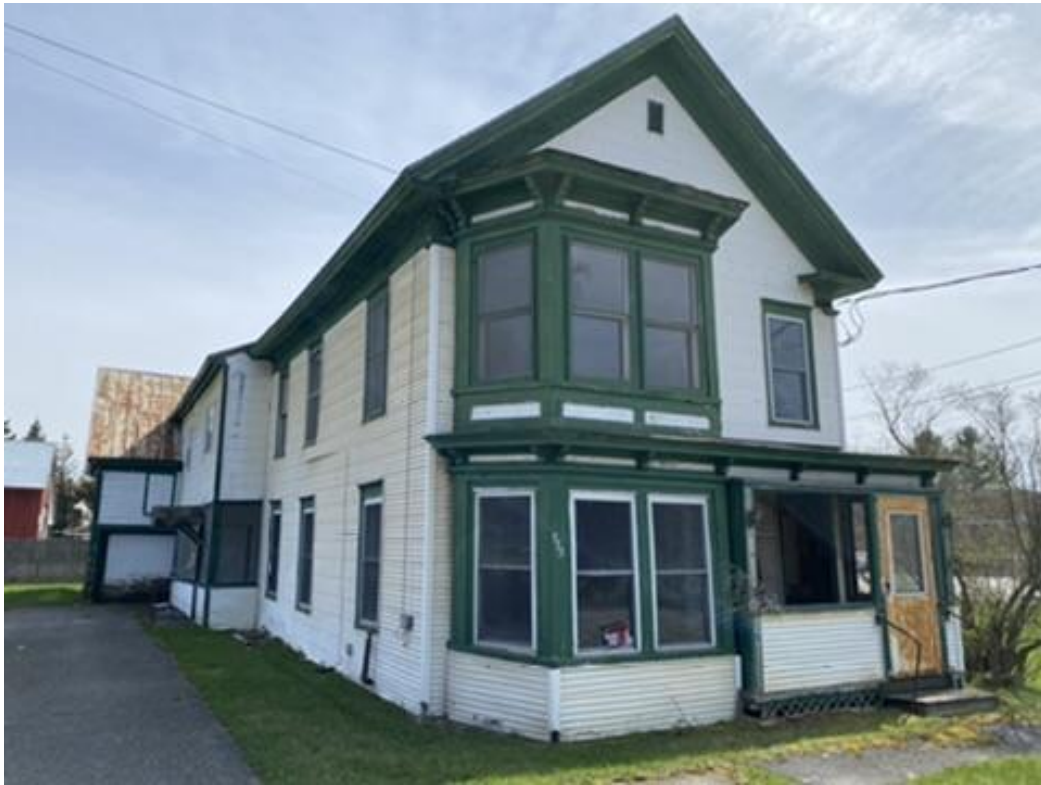
*Figure 1 Front facade of building. Looking south-west.*

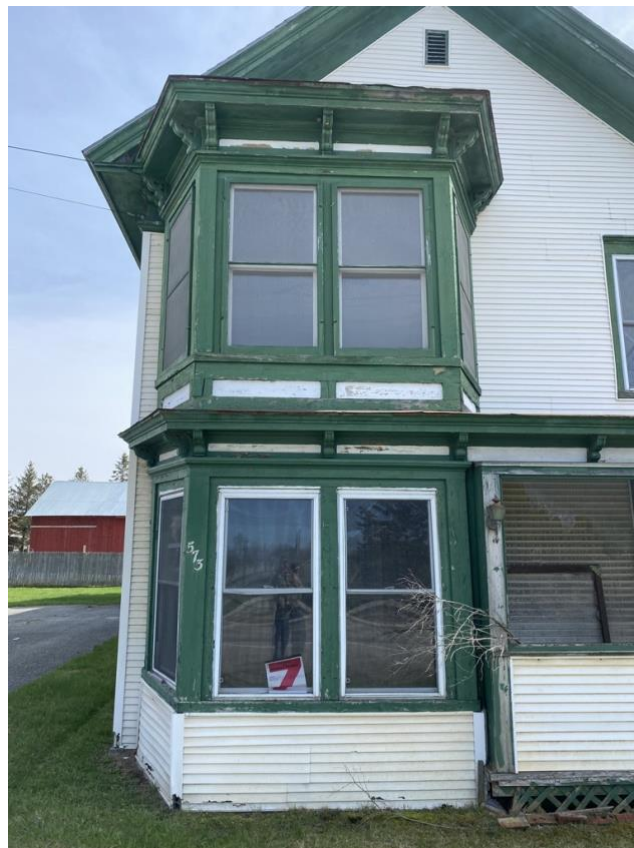
*Figure 2 Detail of front bay. Looking south.*

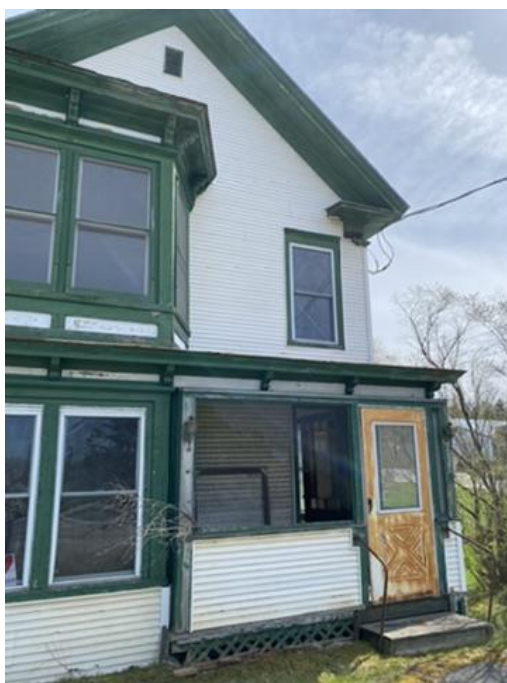
*Figure 3 Front Entrance. Looking south-west.*

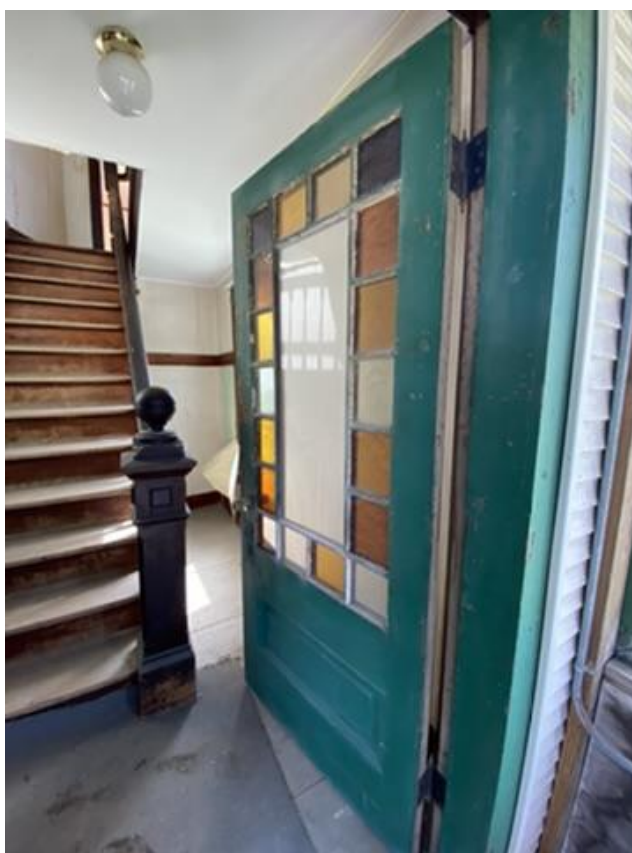
*Figure 4 Historic front door.*

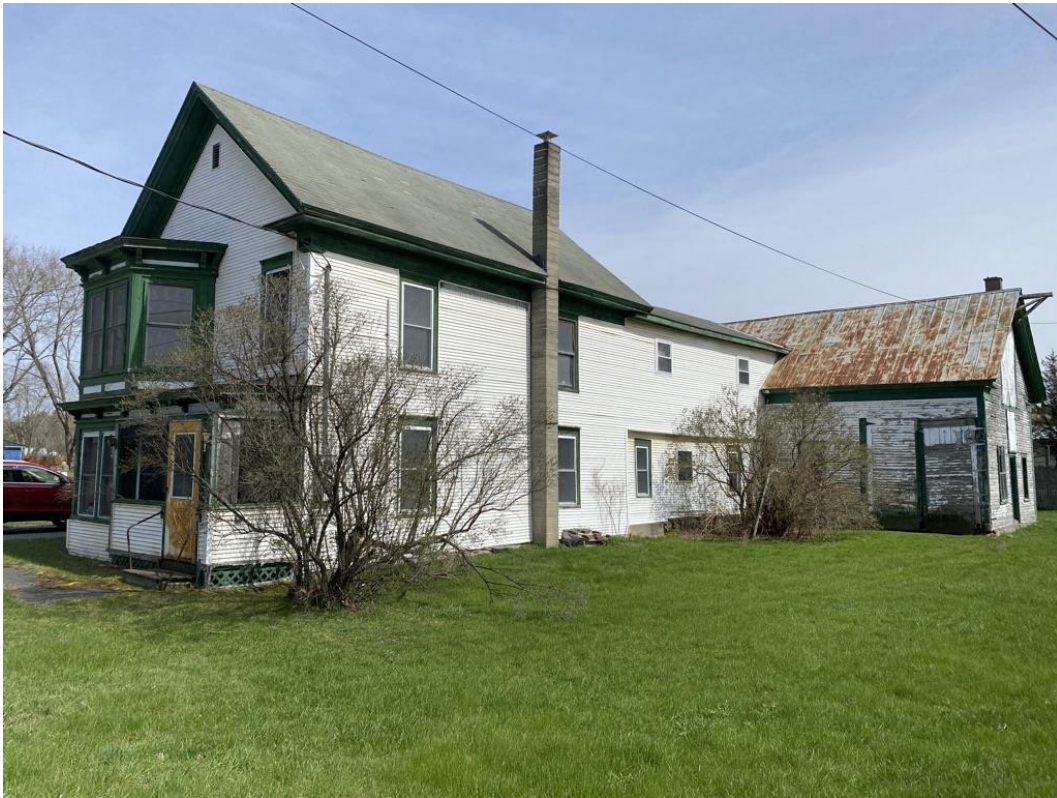
*Figure 5 West side, looking south-east.*

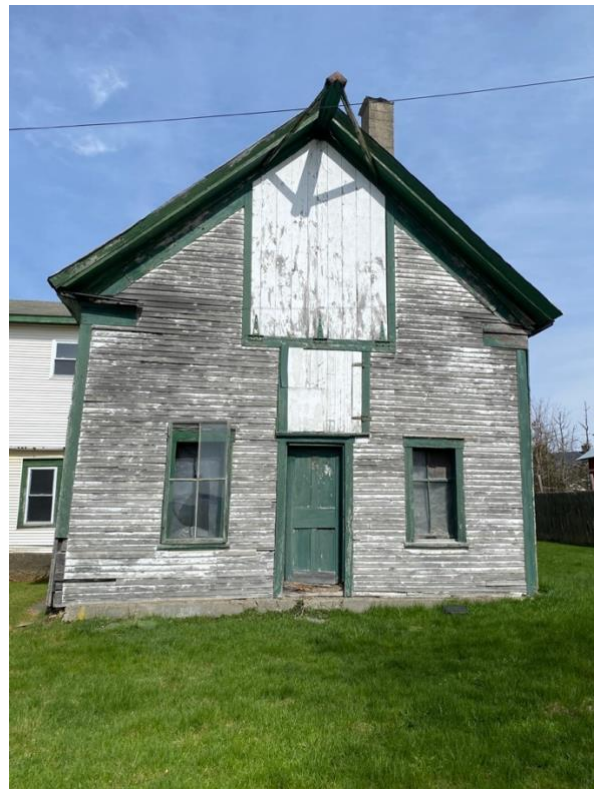
*Figure 6 West side of barn. Looking east.*

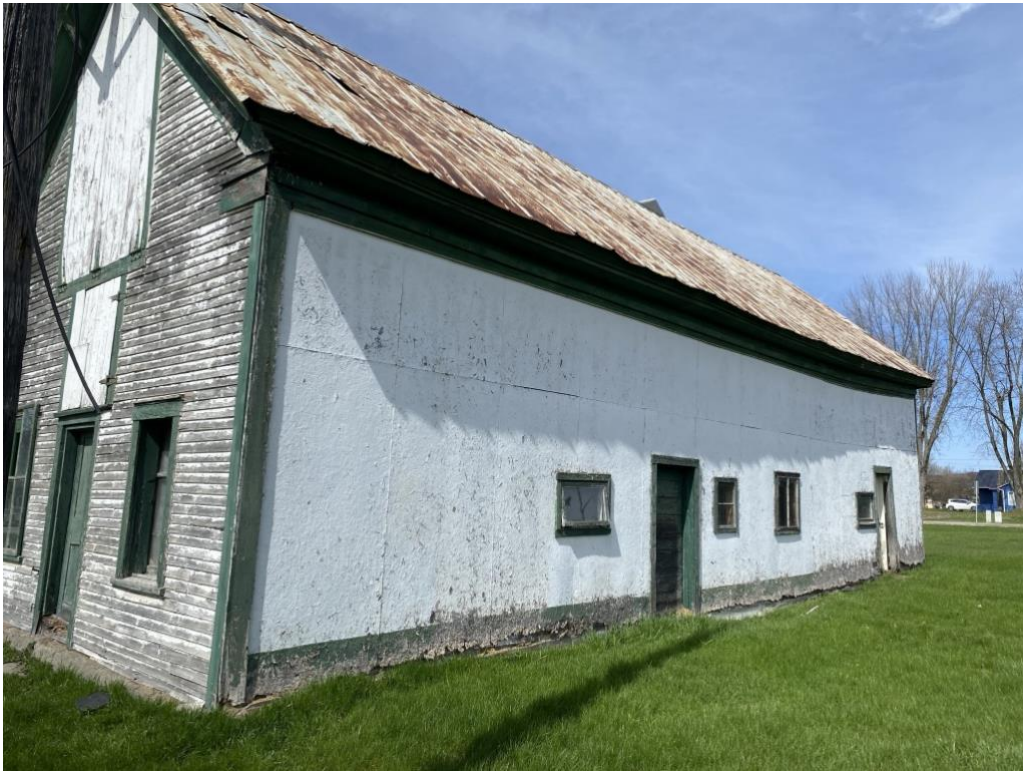
*Figure 7 Rear of barn. Looking north-east.*

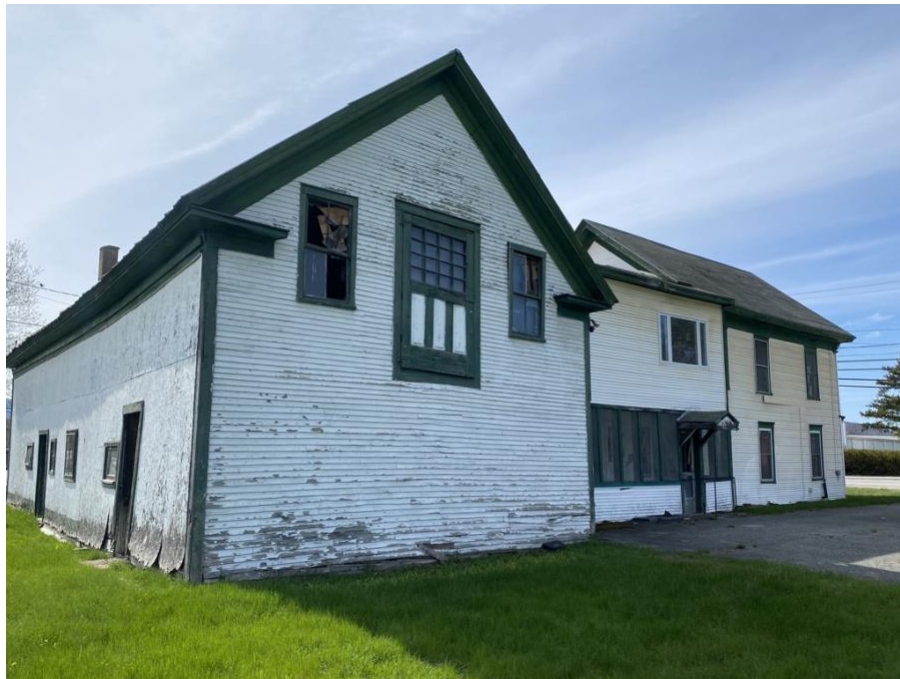
*Figure 8 East side of barn. Looking north-west.*

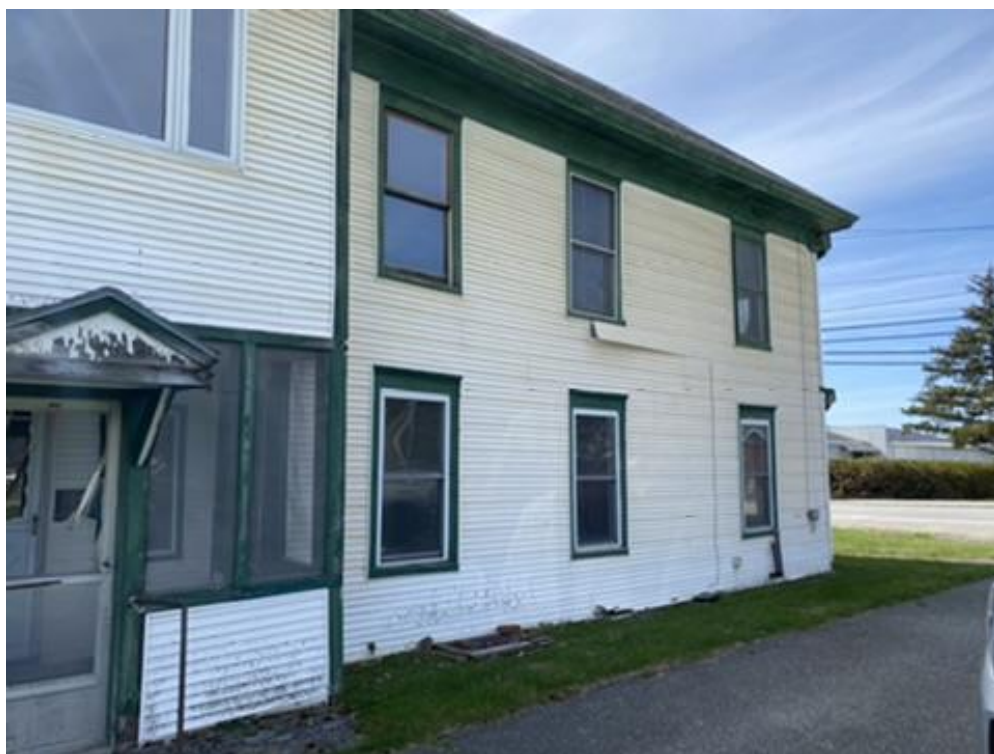
The east side of the building has six aligned windows, three per floor. Behind the main block is a two-story wing that sits just proud of the main block. The east side of the wing has an inset screened porch on the first floor with an additional entry way. The second story has a single double-hung to the back and three-part picture window to the front. The wing has a gable roof with very simple flat-stock trim. Behind the wing is an attached two-story barn, sitting perpendicular to the residence, with a gable roof and wood clapboard siding. At the end of the driveway, facing north, abutting the rear wing is a sliding wood door on the first floor of the barn, with a small hay door above. The east gable-end of the barn has a large, paneled, half glazed, door centered on the second story, with two-over-two, historic double-hung windows on either side. The barn has a corrugated metal roof, supported by trim that matches the main block, and a concrete foundation.

*Figure 9 East side of main block. Looking north-west.*

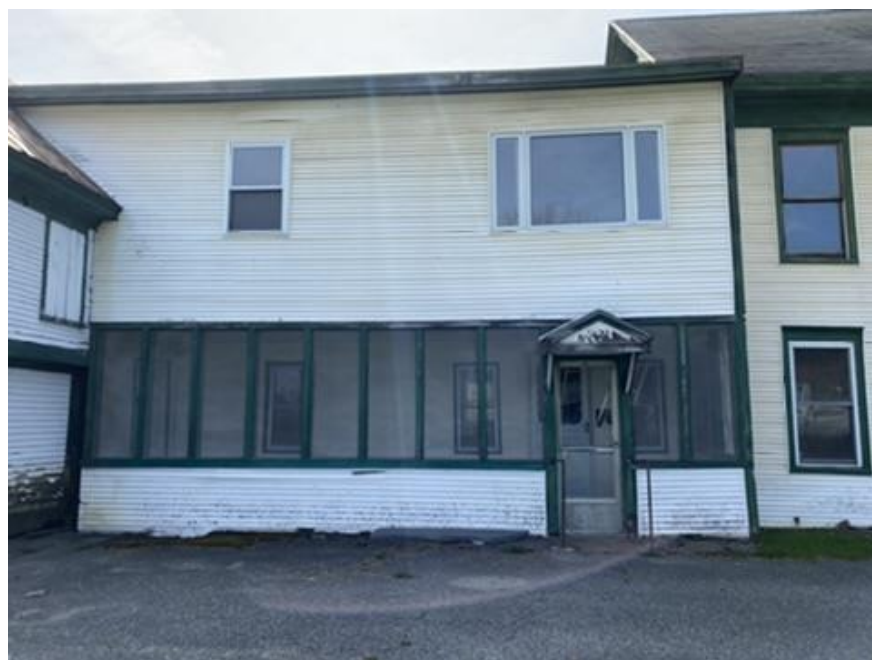
*Figure 10 East side of wing. Looking west.*

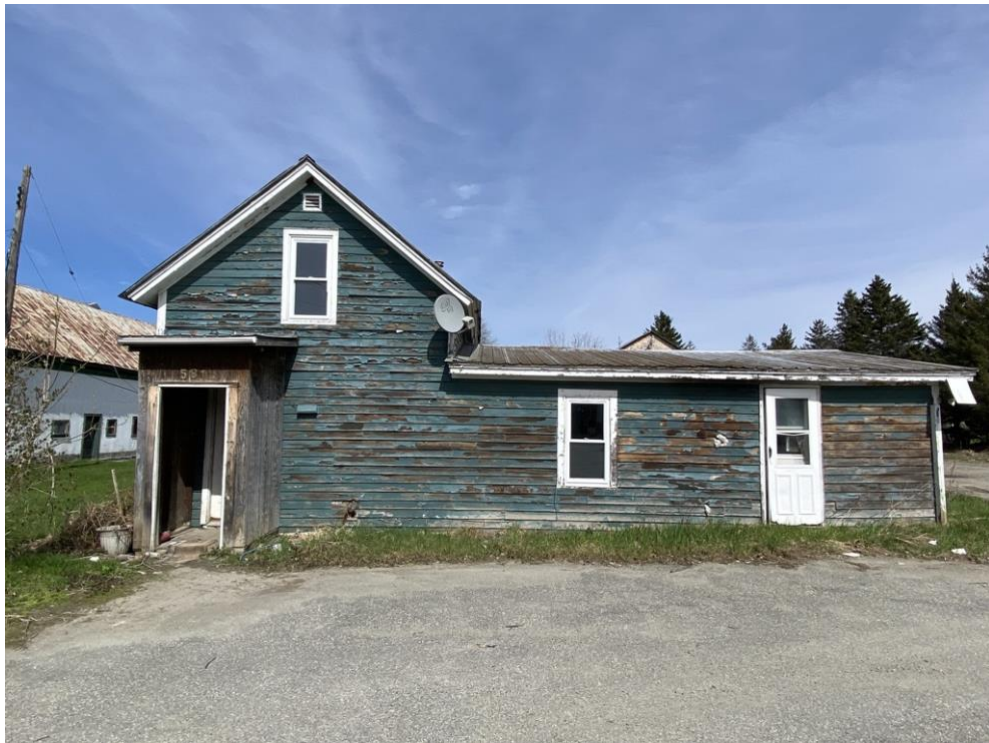
Behind the farmhouse is a small one-half-story building built after the main house, as it is not in the 1889 birdseye depiction. The building has wood clapboard siding and a corrugated metal roof. The main entrance is on the northern side of the front façade, covered by a plywood portico. A single replacement window sits under the eave of the roof. A large single-

*Figure 11 Related structure in rear of house. Front facade, looking east.*

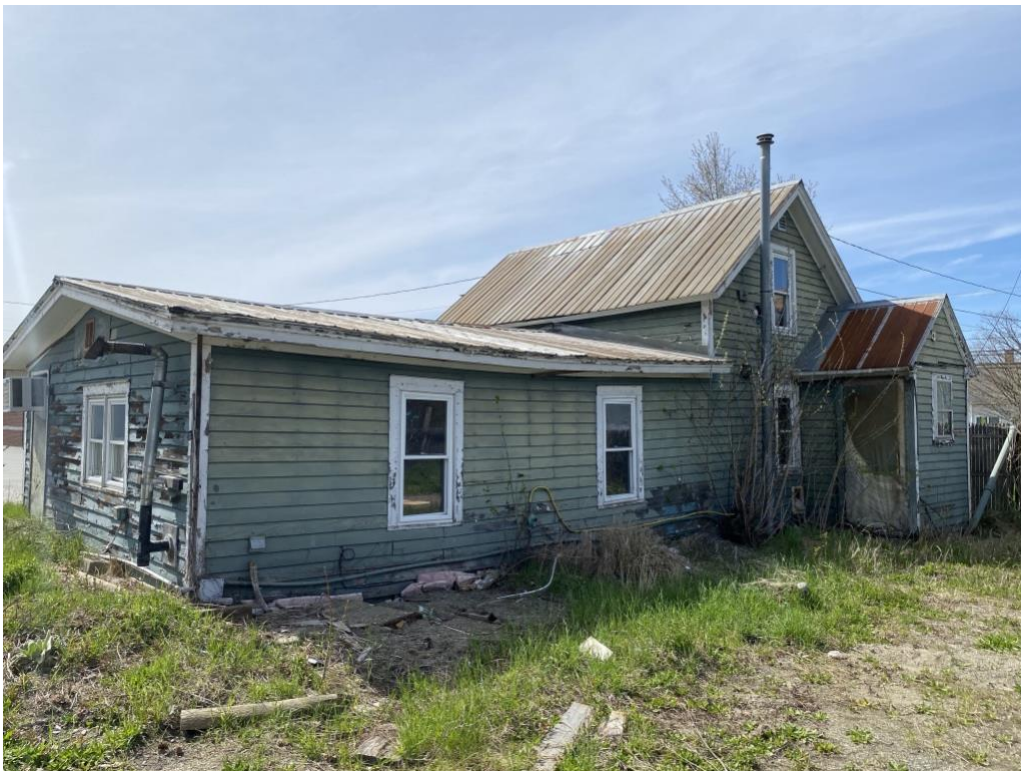
story, gable-end ell spreads to the south, which is likely original to the structure. The front face of the ell has a replacement window and another entrance towards the south. The trim and fascia details are simple flat stock. The southern gable-end of the ell has a single double replacement window. The east side has two single replacement windows. The east of the main block has a single window towards the south and a small gabled wing with no windows. A single replacement window rests under the eastern eave. The northern side has two replacement windows.

*Figure 12 Rear or related structure, looking north-west.*

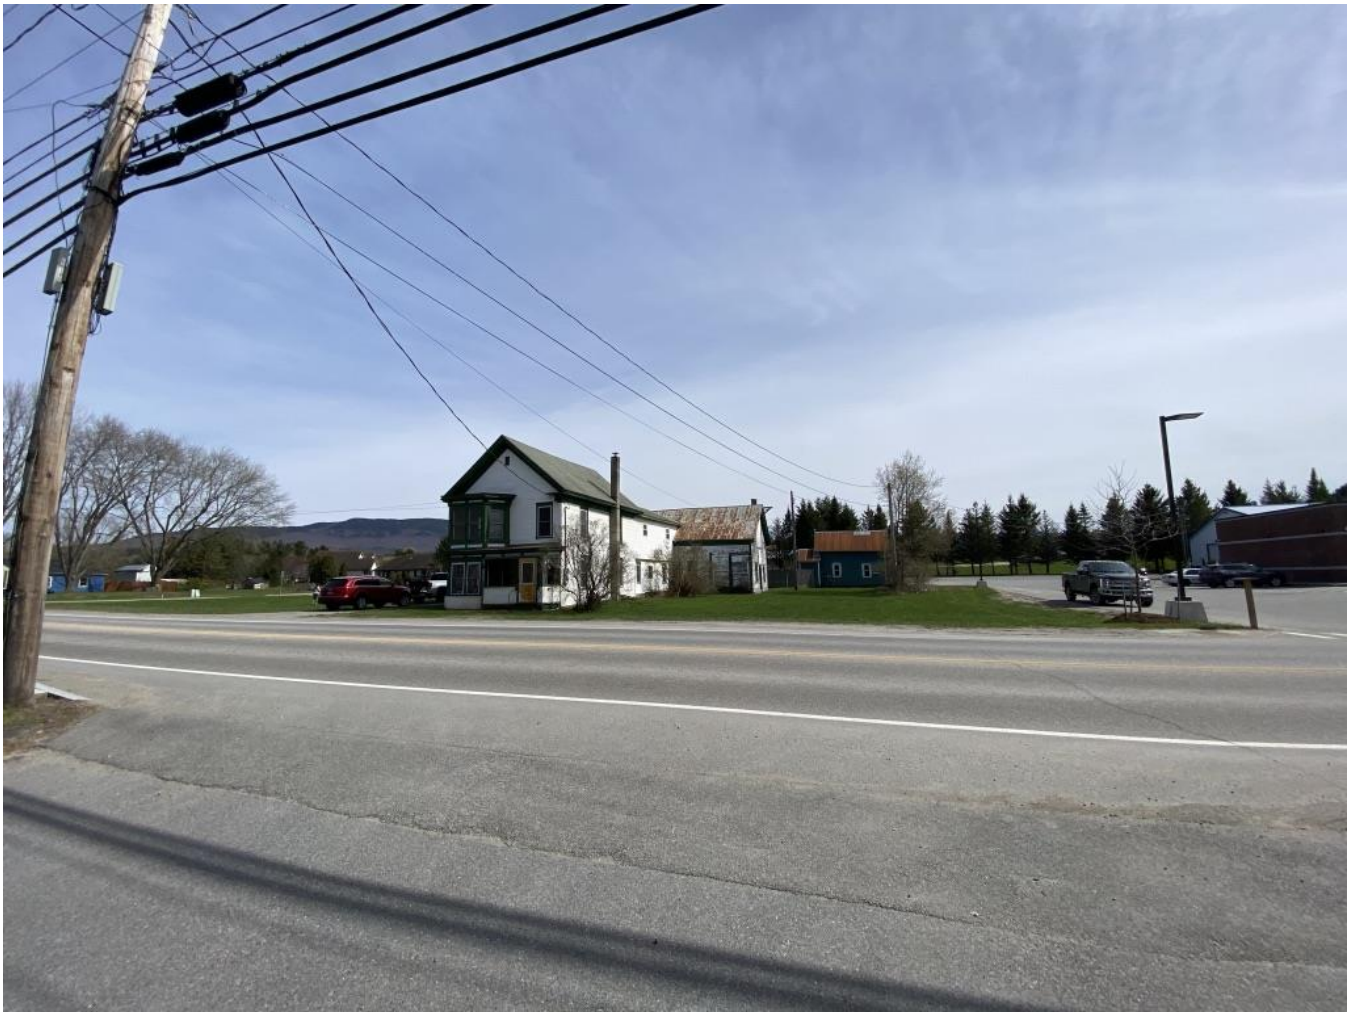
*Figure 13 Area around building, gas station is to the left. Looking south.*
